Inspecting bearings

Application Note

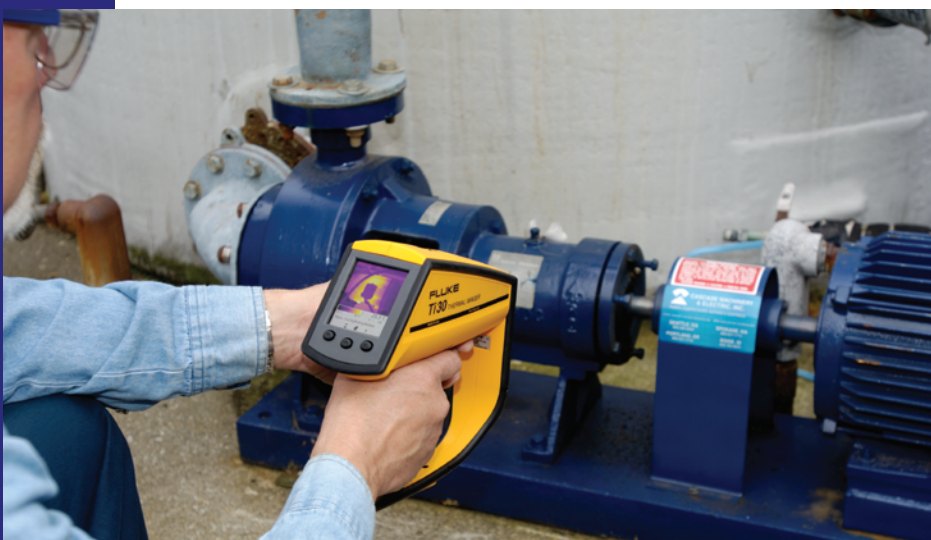
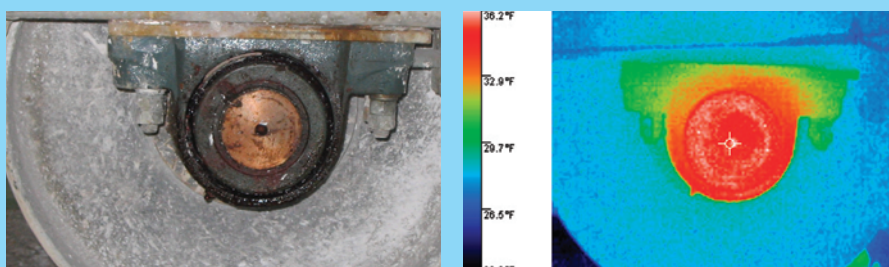
This overheating shaft and bearing may be an indicator of bearing failure, lack of proper lubrication, or misalignment.

Problems with bearings are usually found by comparing the surface temperatures of similar bearings working under similar conditions. Overheating conditions appear as “hot spots” within an infrared image and are usually found by comparing similar equipment. In checking motor bearings, this procedure entails comparing end bell (for motors and bearings of the same type) or stator to end bell temperatures.

heat. Thermal imaging lets you literally "picture" this process while revealing the condition of bearings. When thermal images indicate an overheating bearing, you should generate a maintenance order to either replace the bearing or lubricate it. Vibration analysis or another PdM technology may help you determine the best course of action.
